# Pipe Bursting Installation of Watermains in Telkwa

Paul Wellington AScT,  
Dayton & Knight Ltd.

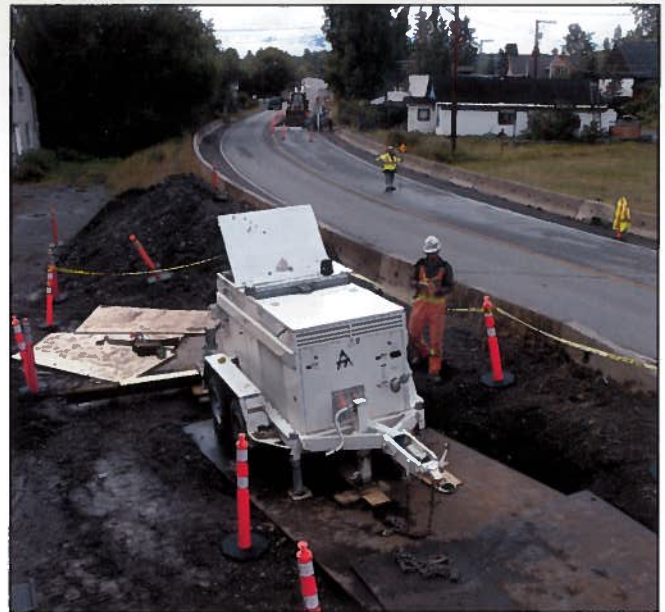
*The existing main ran under the shoulder.*

This main had experienced several failures in recent years that required excavation of the highway road structure to repair. Because the location of many of the watermain valves is unknown, water supply to large areas of the community had to be shut down to make the repairs.

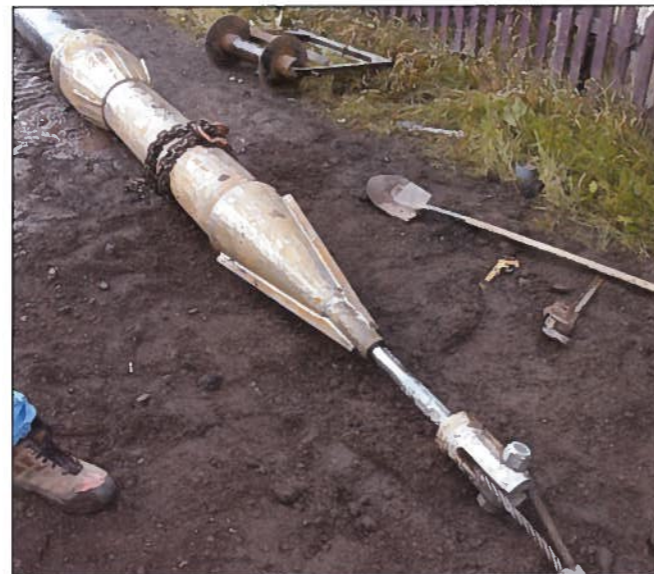
The 200 mm burster with rear expander and "schnoze" adapter.

The 150 mm diameter main along the highway was burst in eight sections of 60 to 140 m long. Entry and exit pits were excavated using trench shoring to minimise the size of the excavations. Pipe was butt fused into the appropriate length sections and staged behind the entry pit. A 200 mm burster with a 350 mm diameter rear expander were used and were powered through a 75 mm diameter air hose from a 13,000 CFM compressor. A "schnoze" adapter on the front of the burster was used to guide it along the existing pipe alignment. A 20 tonne trailer-mounted winch pulling on the "schnoze" was

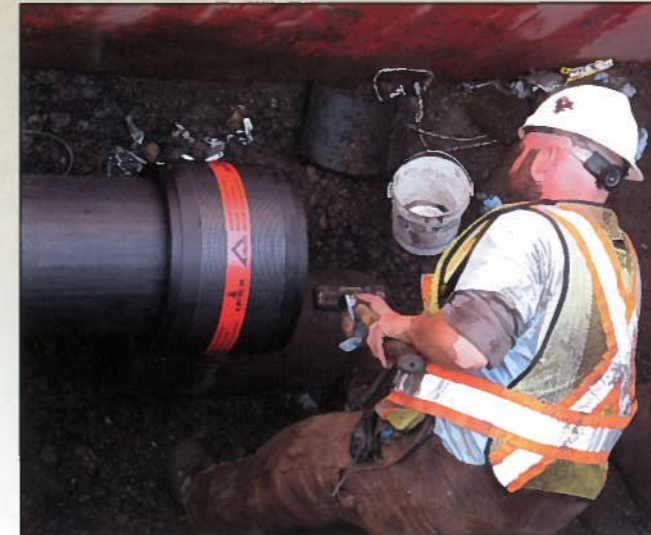
The new sections of HDPE main were joined using electro-fusion couplings.

used to assist the burster. Each section took approximately a day and a half to prepare and about four to six hours to burst. The existing valves, tees, and bends were burst as the new main was installed, saving the need to locate and remove them. The sections of new main were joined using electro-fusion couplings.

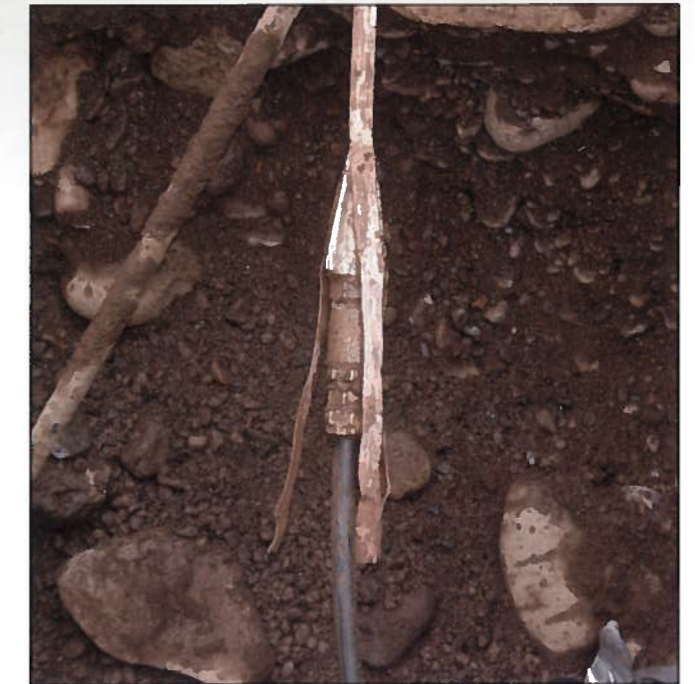
Service connections under the highway were replaced using a static burster.

The existing 19 mm diameter copper service connections under the highway were replaced with 19mm polyethylene pipe using static bursting. A cone splitter towing the new pipe is pulled through the existing service using a steel cable pulled by a backhoe. In most instances, the existing copper pipe was pulled out ahead of the new pipe and was able to be recycled.
